Basic Imagery Interpretation Report

Chu-hsien Chemical Plant

Chu-hsien, China

RCS 13/0081/69

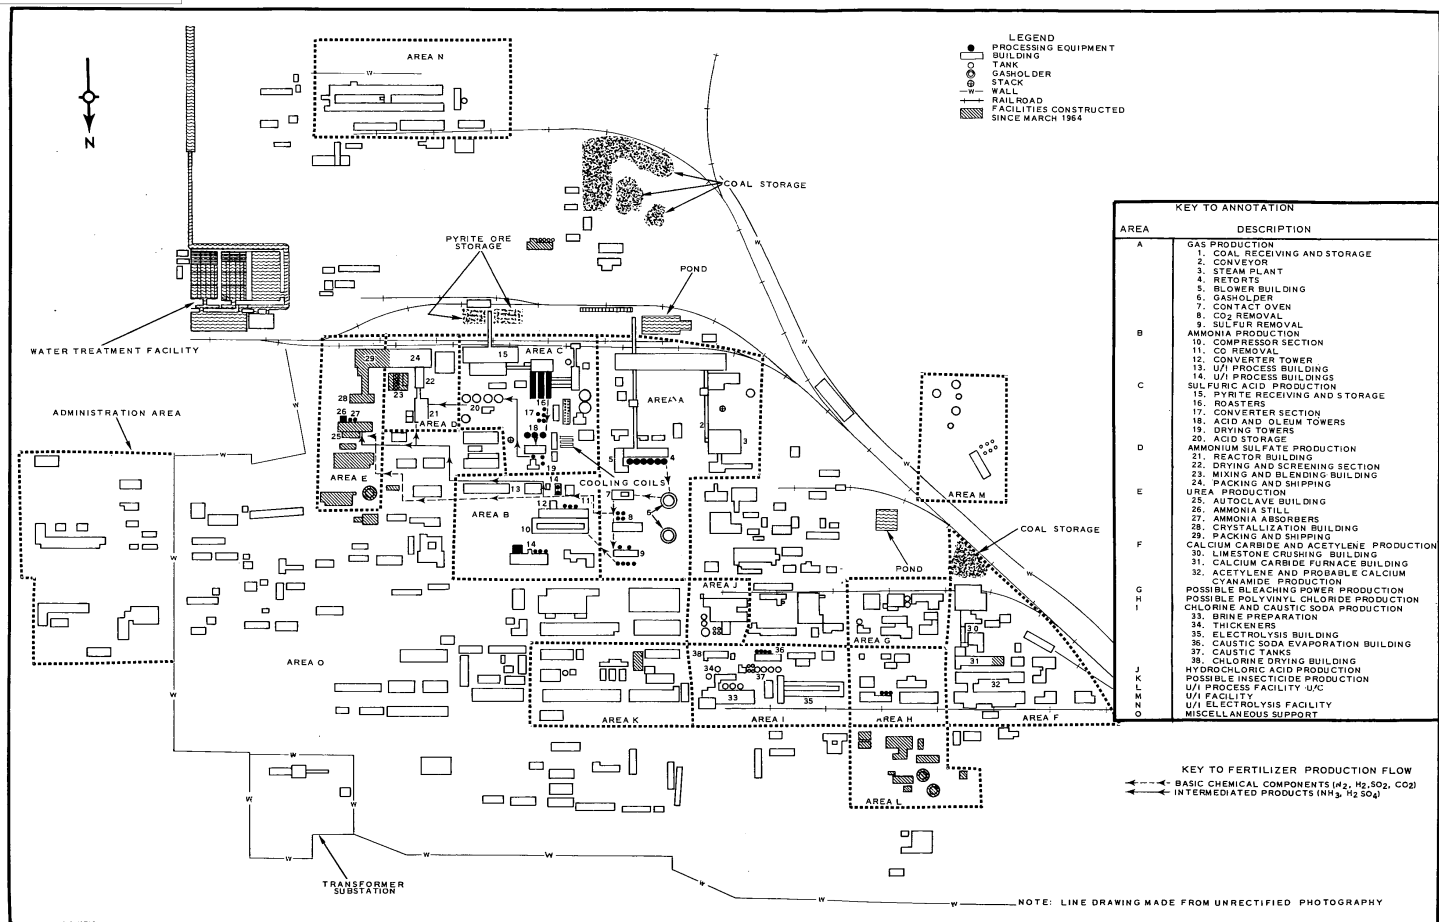
FIGURE 3. CHEMICAL PLANT, CHU-HSIEN, CHINA

This chemical plant measures approximately 5,800 by 3,900 feet and occupies about 340 acres. The plant is secured by a wall on three sides. An administration area is situated outside the east security wall (Figure 3). An extensive workers' housing area has been constructed 0.4 nm to the east of the administration area near the Wu Chi River.

This large integrated chemical plant produces a wide range of chemicals. The major end products include nitrogenous fertilizers, chlorine, caustic soda, hydrochloric acid, and probably calcium cyanamide. The specific production areas and major facilities are depicted and annotated on the line drawing (Figure 3).

The Chu-hsien Chemical Plant is located 3.8 nautical miles (nm) south-southeast of the center of Chu-hsien and is served by a spur of the Chiang-shan to Chu-hsien rail line (Figure 1). A large water treatment facility is located in the southeast corner of the installation, and a transformer substation is in the northeast corner (Figures 2 and 3).
